## EASY SOLUTIONS BULLETIN

### Axial rod & gaiter kits for extra strength and protection

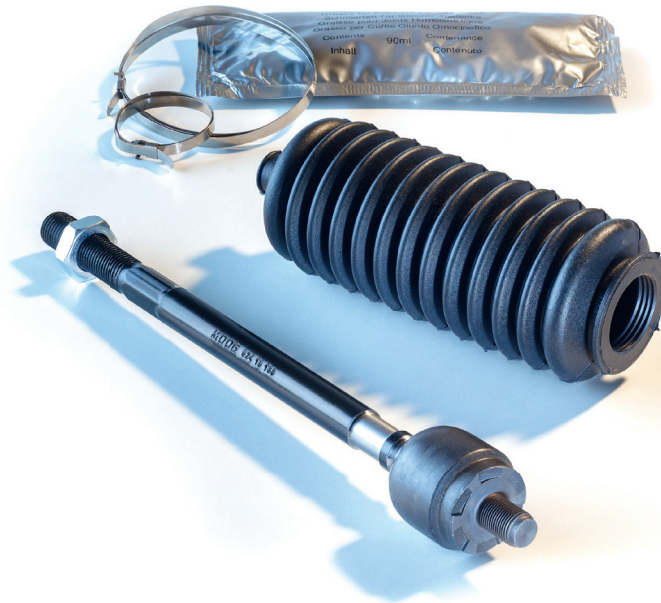
In most cases the axial rod fails due to a split gaiter which allows dirt and water to contaminate the axial rod joint. Therefore each time an axial rod is replaced, it's recommended to replace also the gaiter.

**MOOG has introduced a range of axial rod & gaiter kits that provide all the necessary components for the repair.** Each kit contains an axial rod, a single gaiter, 2 metal ties to ensure a stronger and durable seal and a sachet of grease.
